# 321 BROGDON ROAD

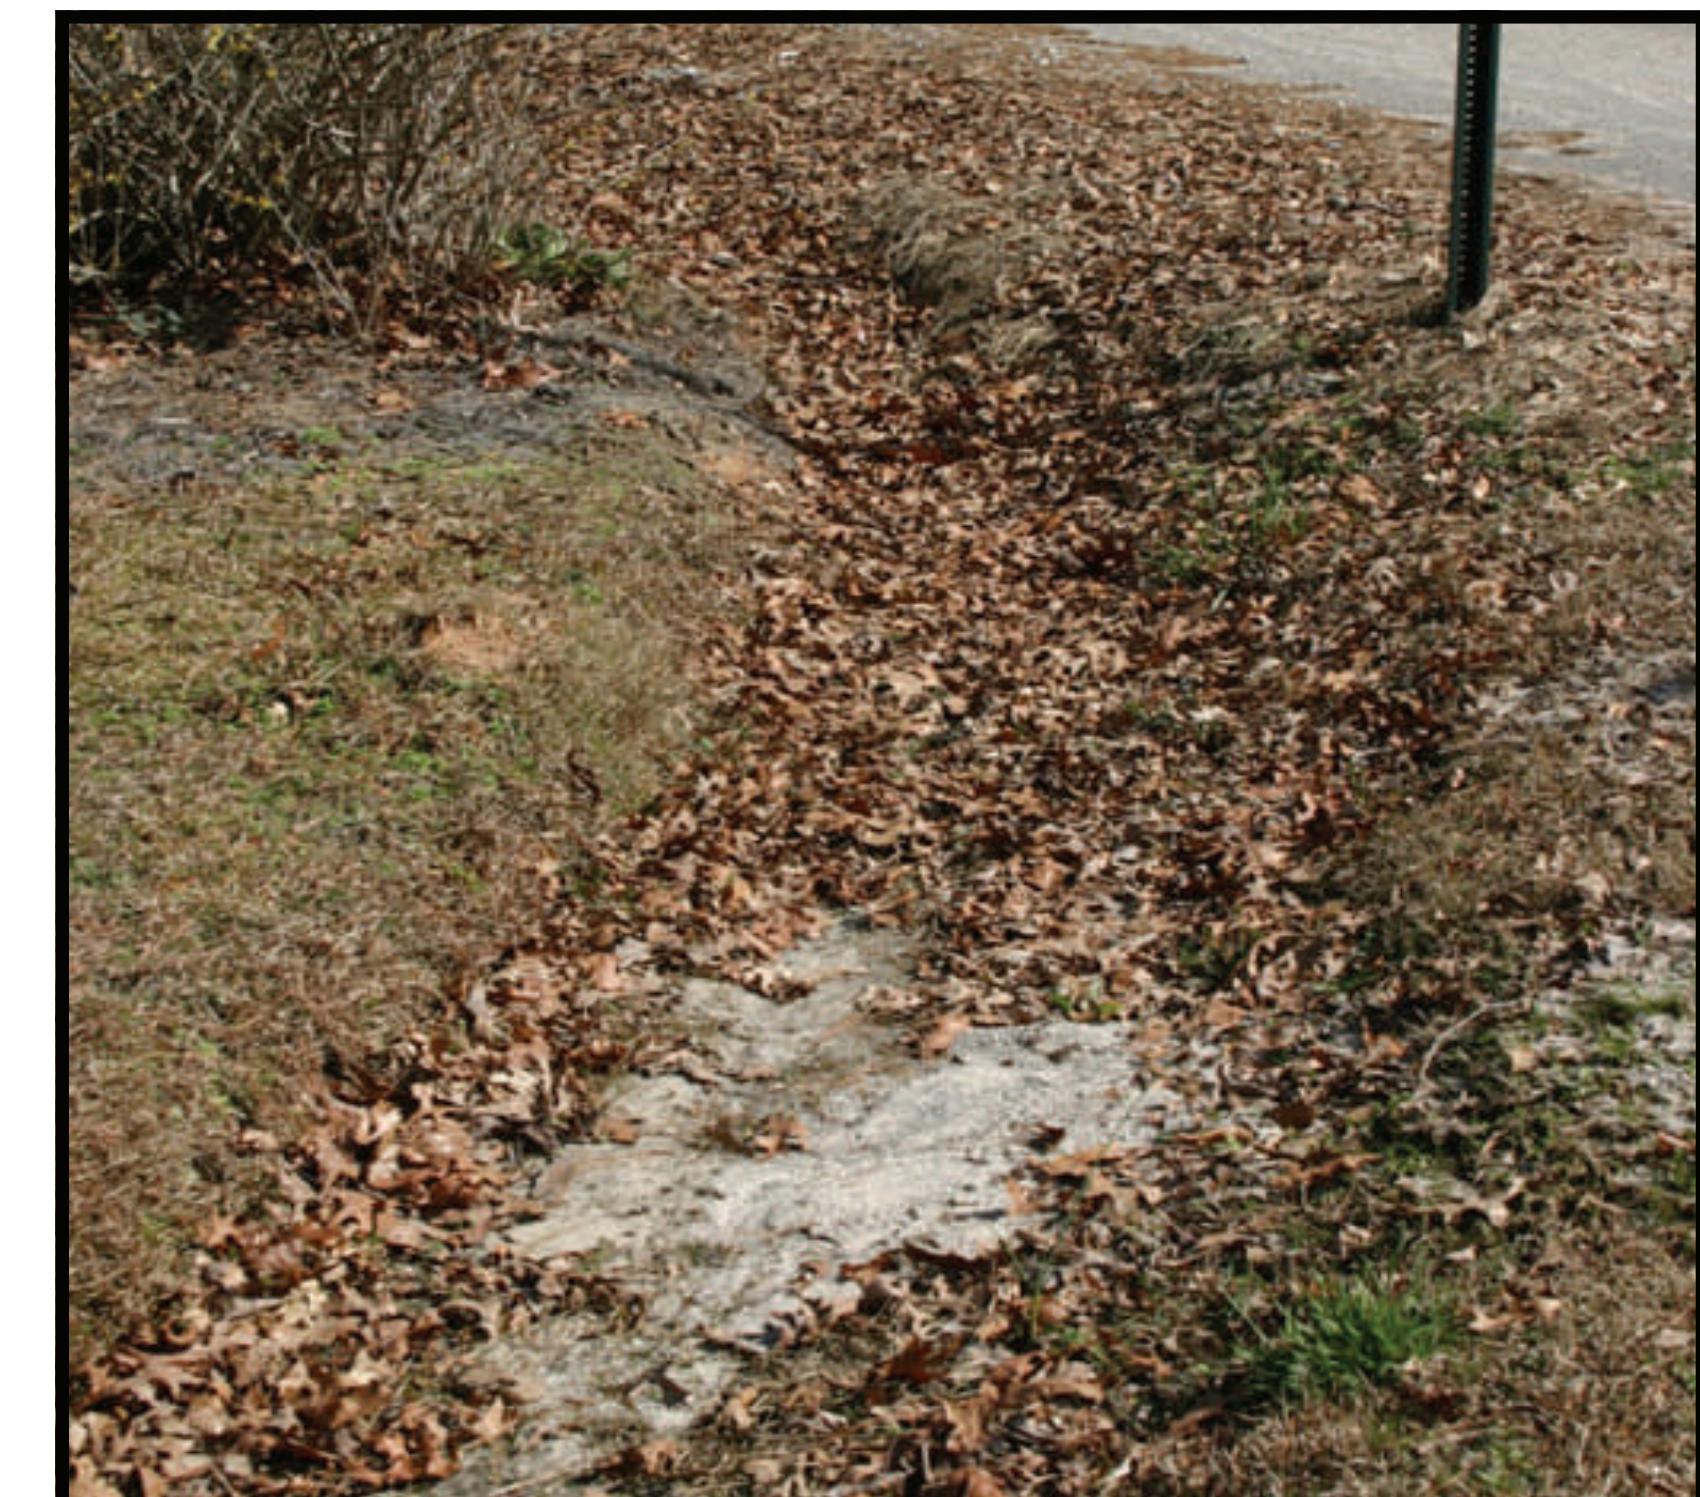
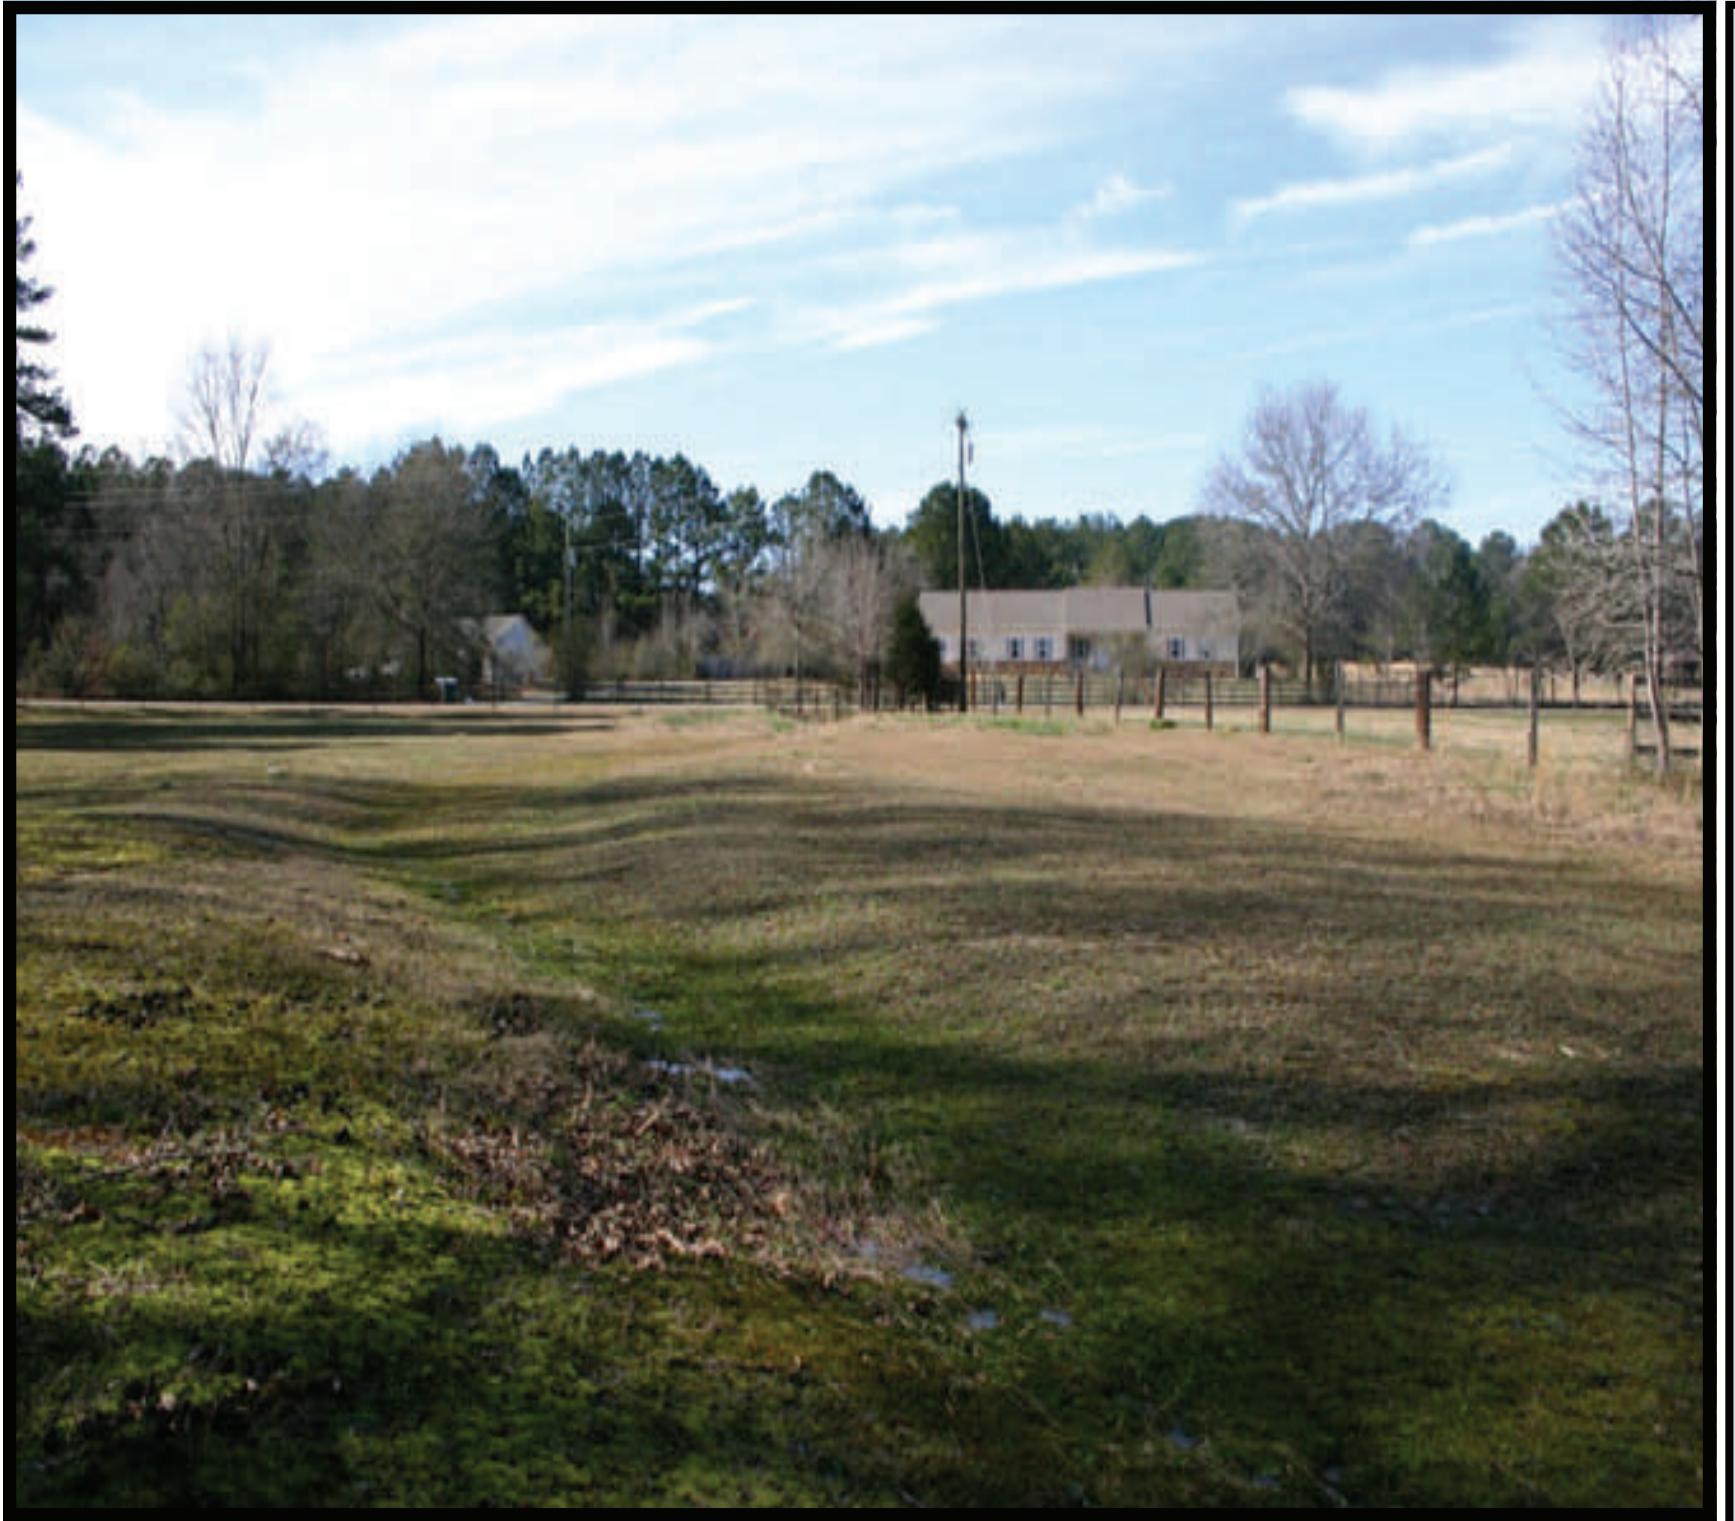
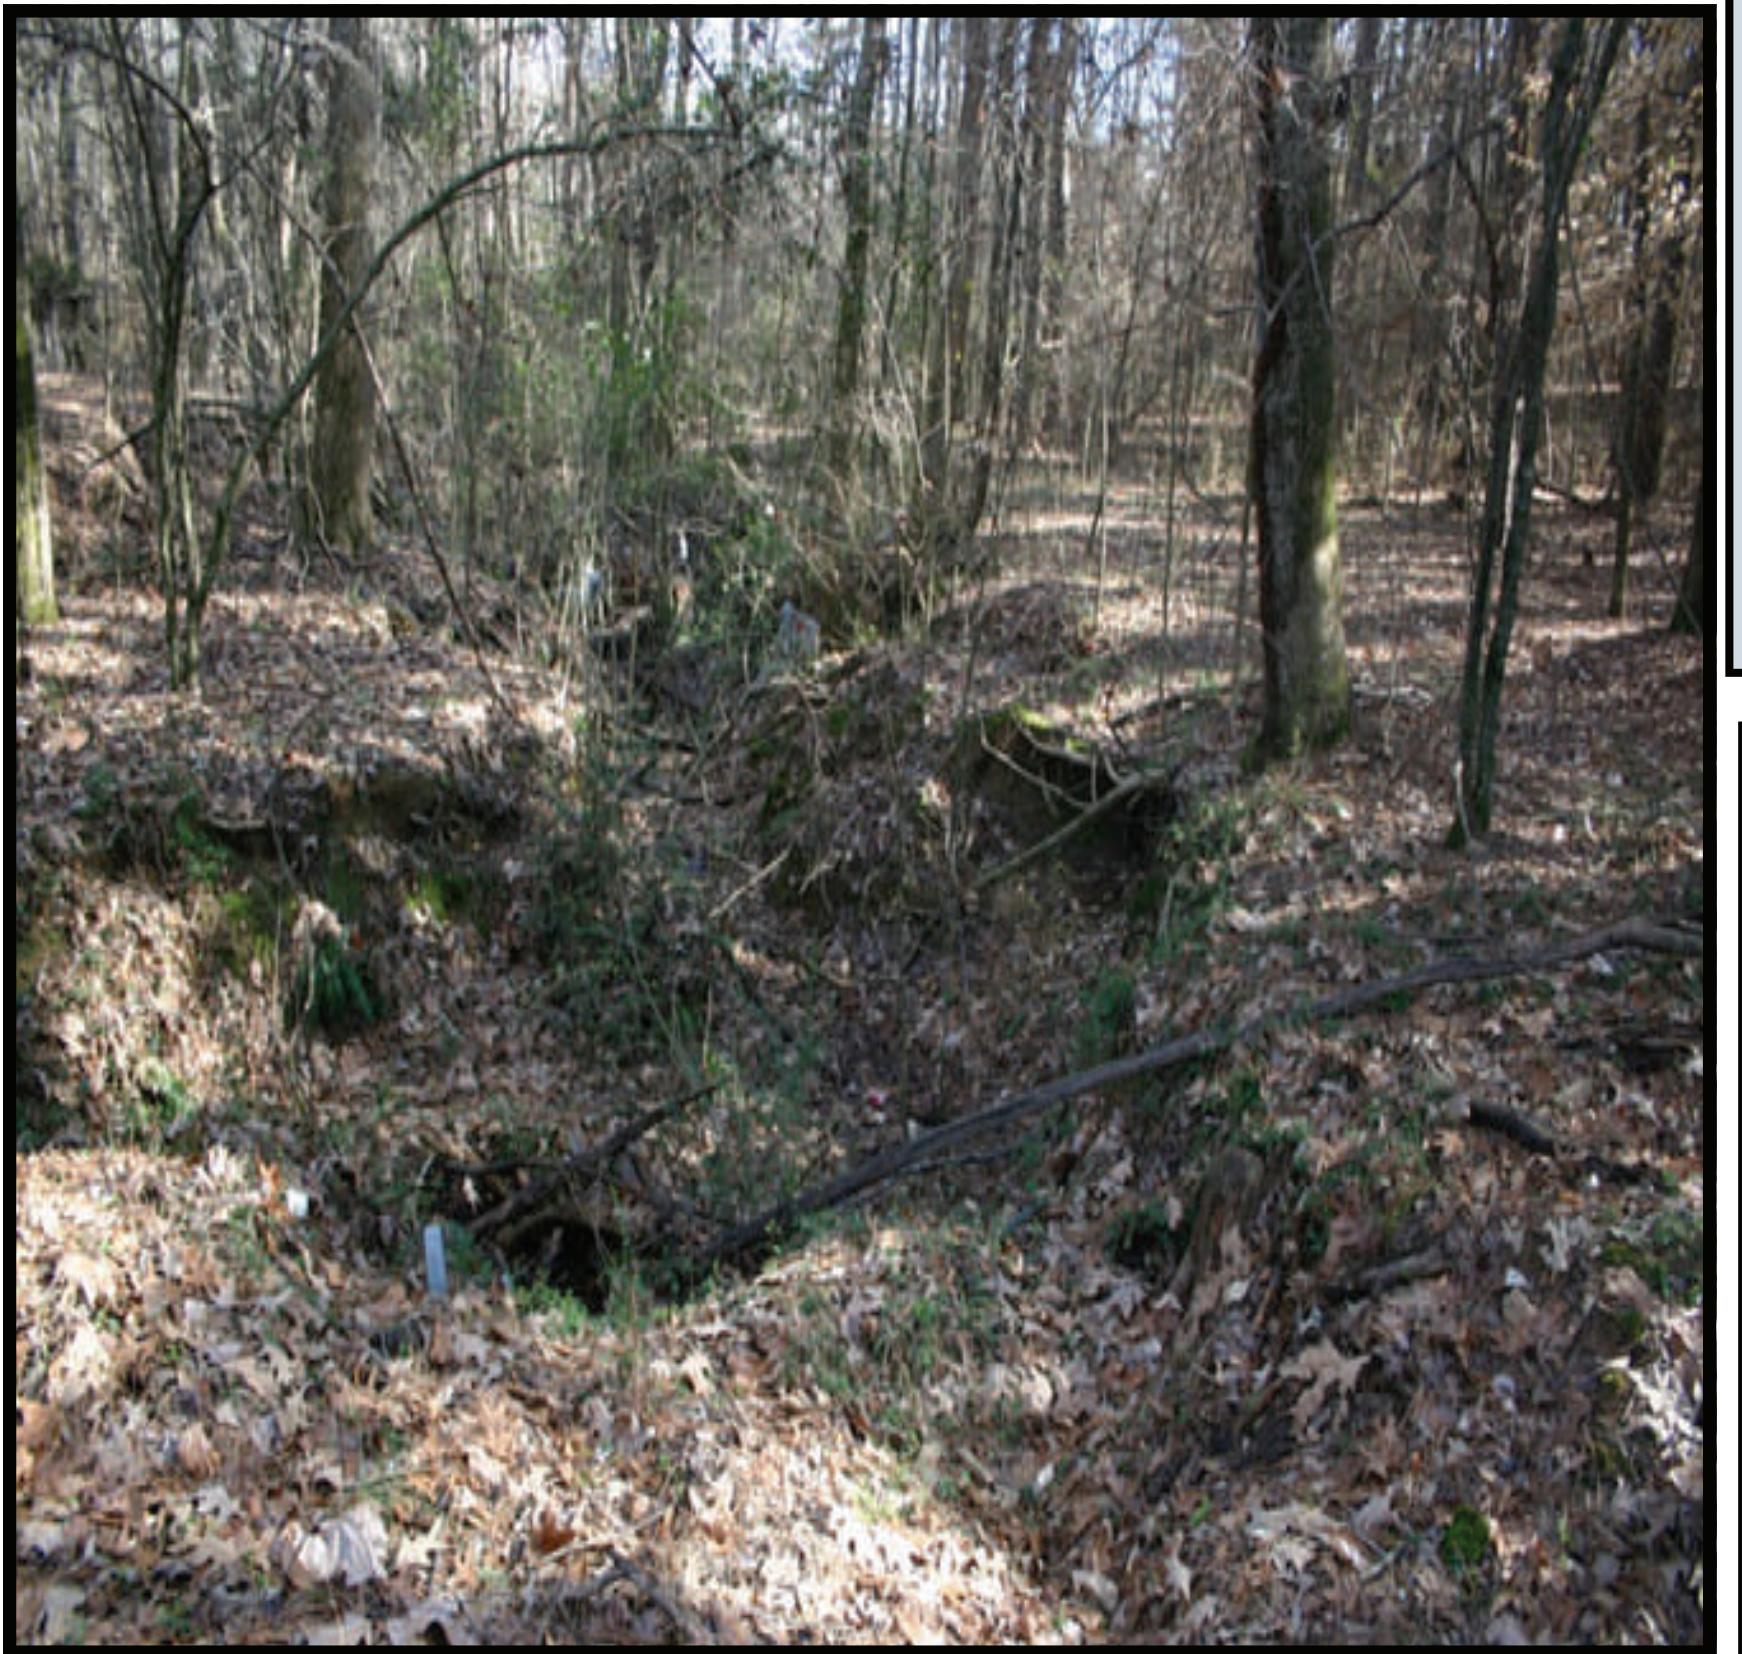
# 150 CRABAPPLE ROAD

- Stormwater travels under the road through the culvert and into drainage swell. Ground is stable with vegetation, standing water pools to the rear of pasture.

- Water velocity picks up at rear of property and erodes soil. Mr. Farmer has used large blocks of concrete to slow the flow.

**Suggested that Mr. Farmer create some type of detention pond to slow down drainage.**

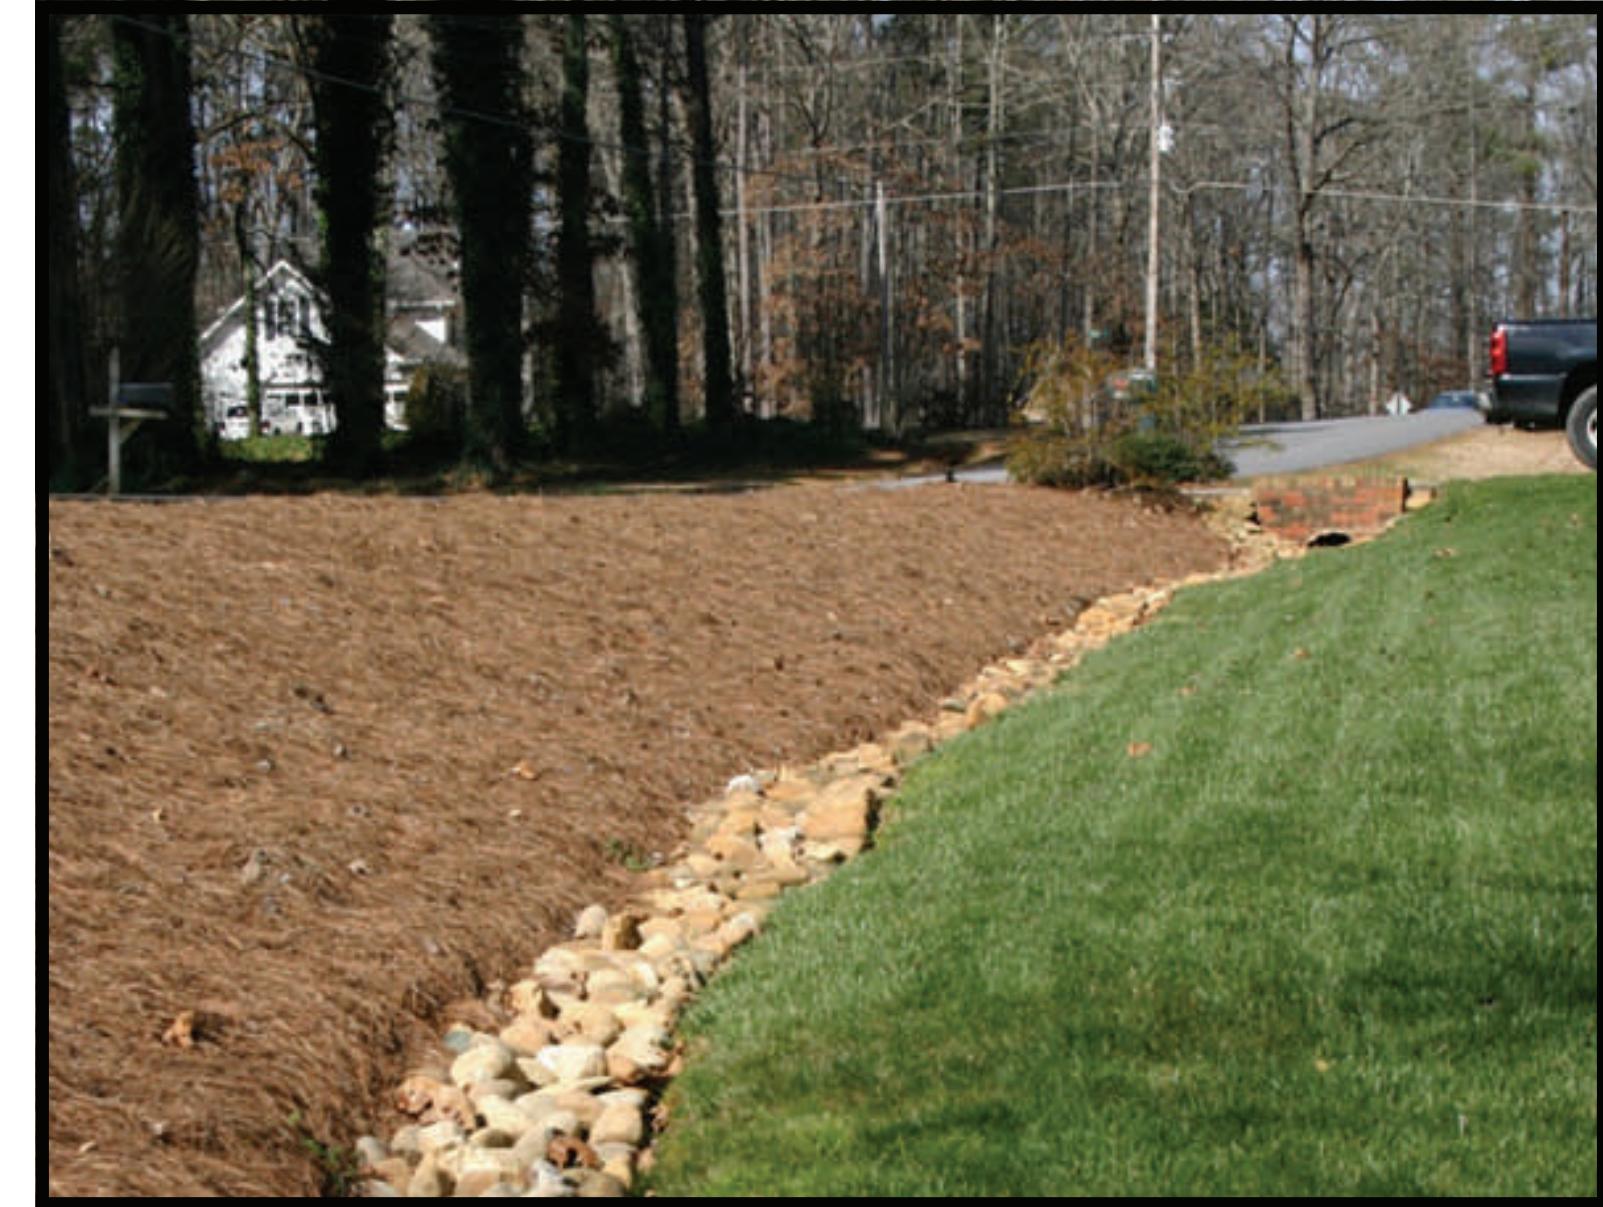
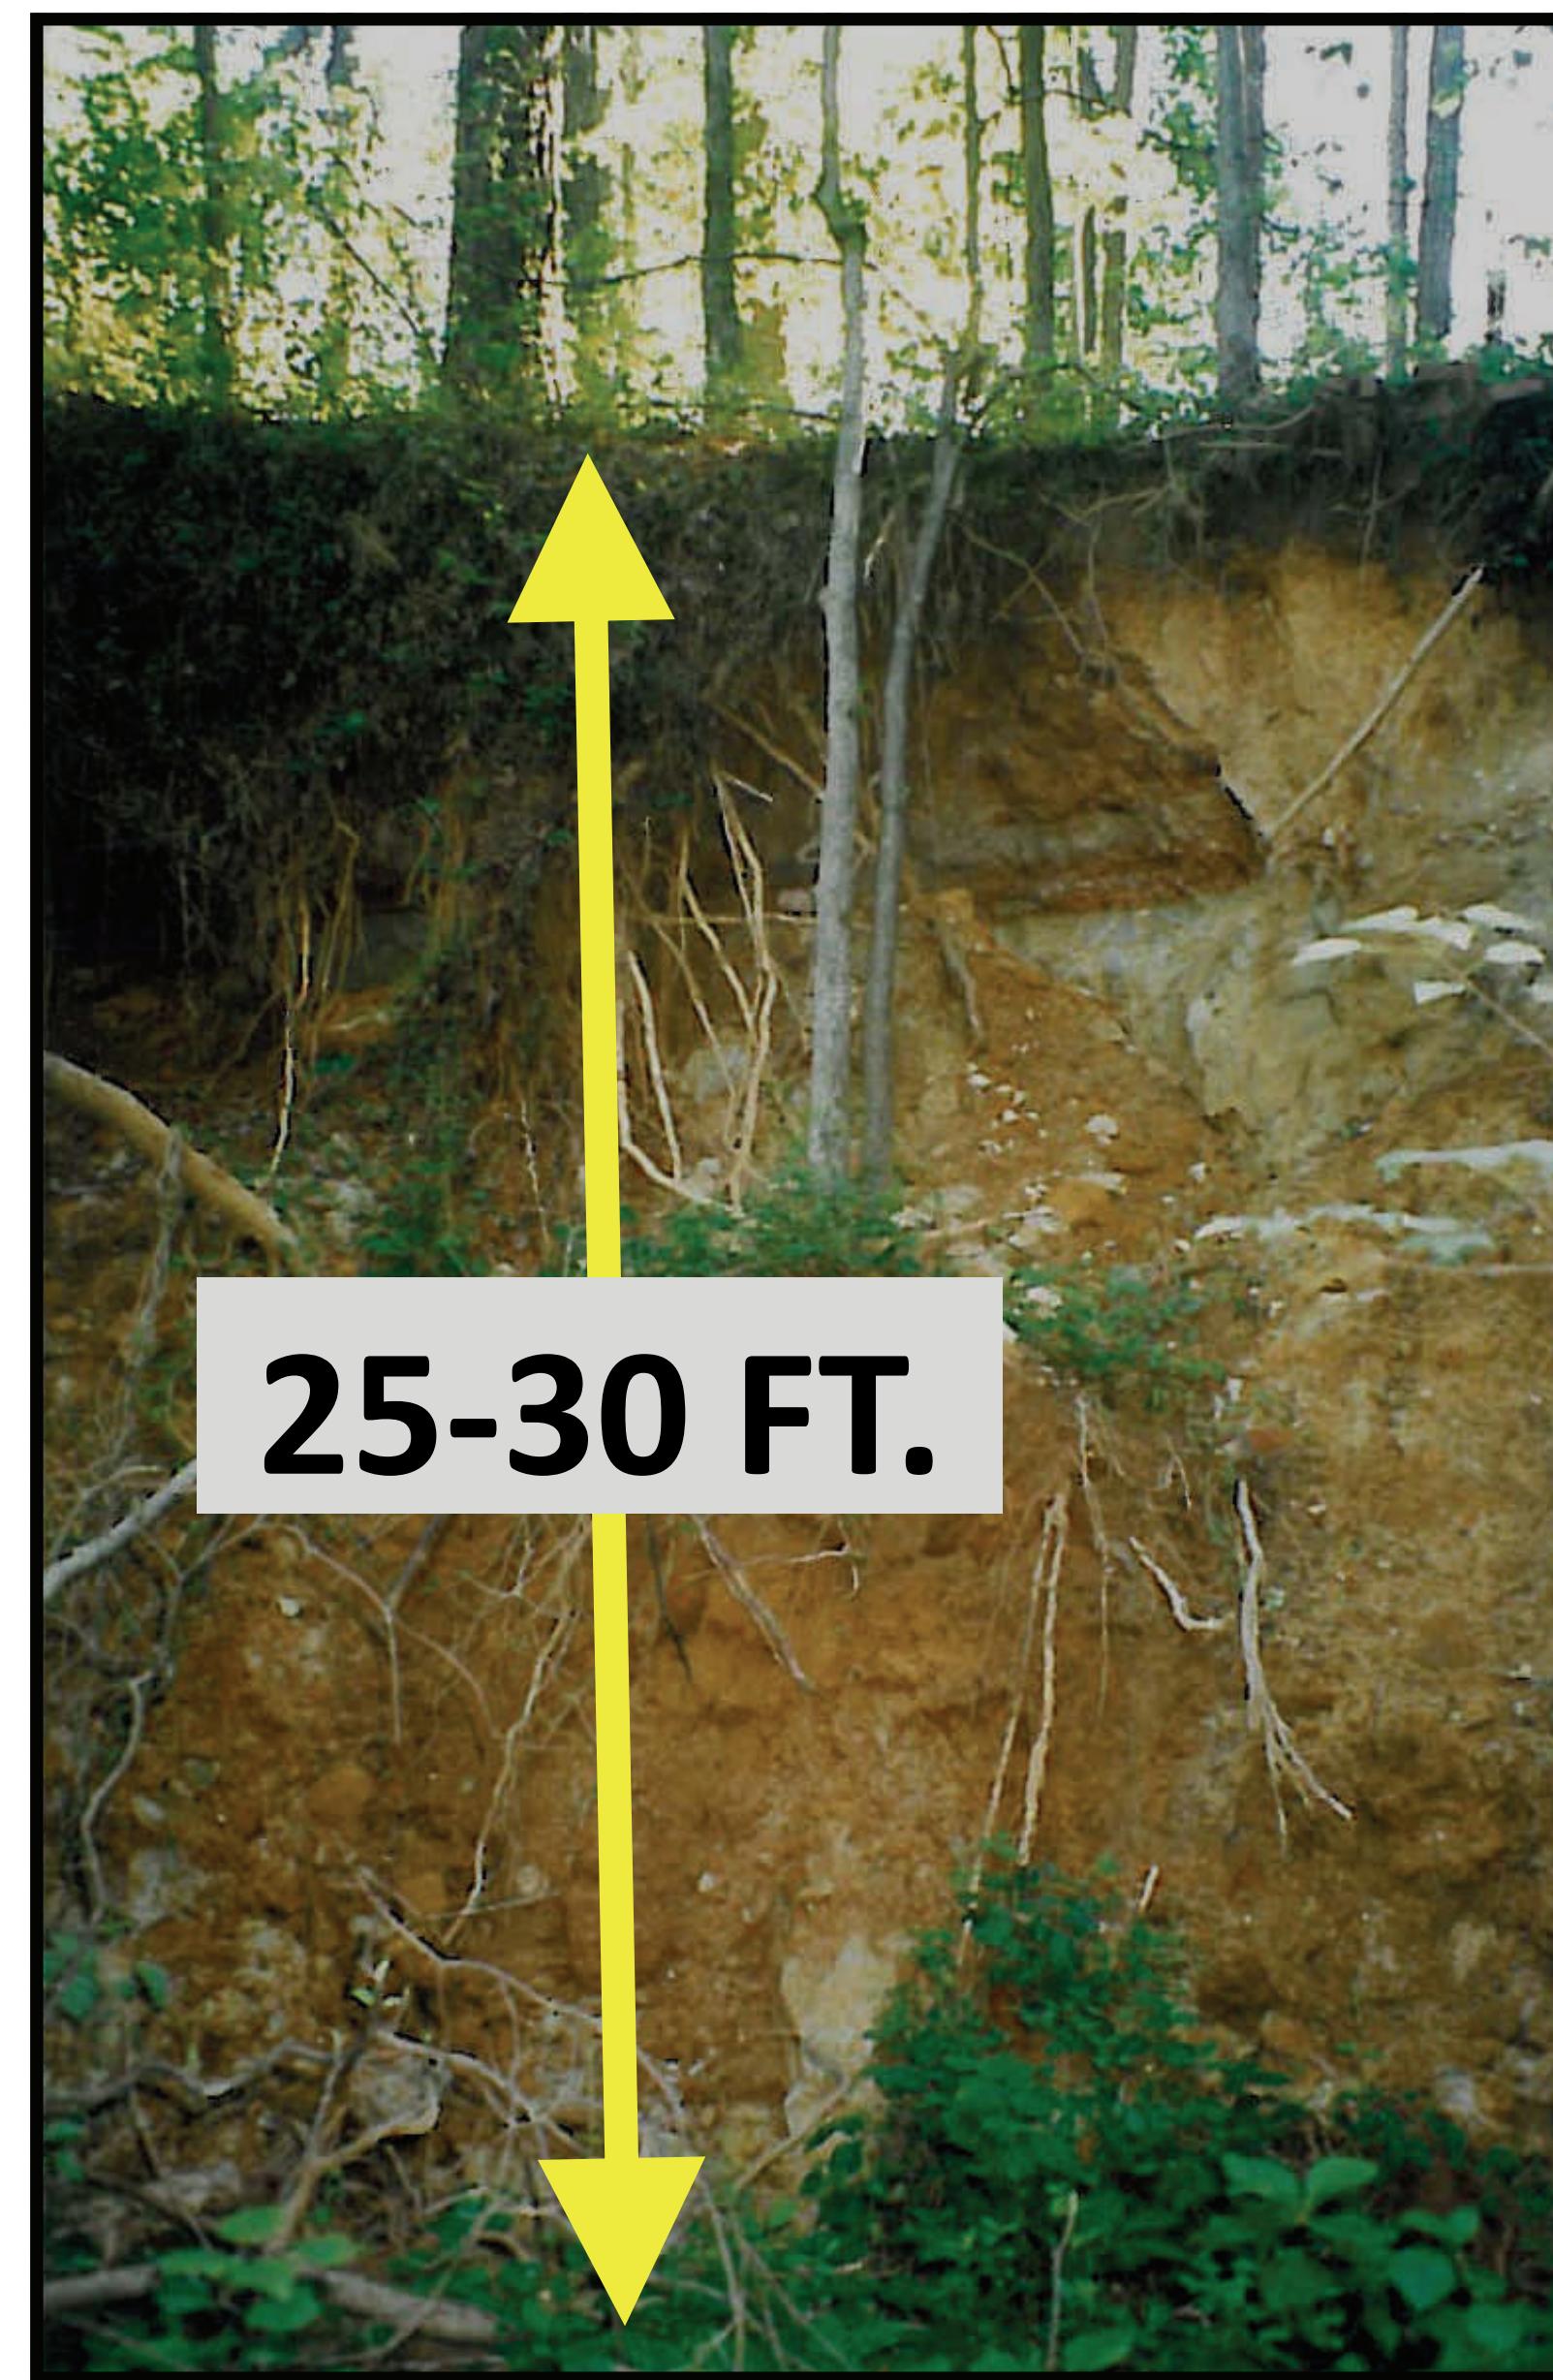
# 295 MERRYDALE ROAD

- A very attractive drainage ditch in the front yard, heading down toward culvert that outflows on side-yard property line where a very deep and wide channel has been created.

**The scale of this erosion is huge and requires expensive stream bank mitigation. Staff is looking for grants that can be used on private property.**

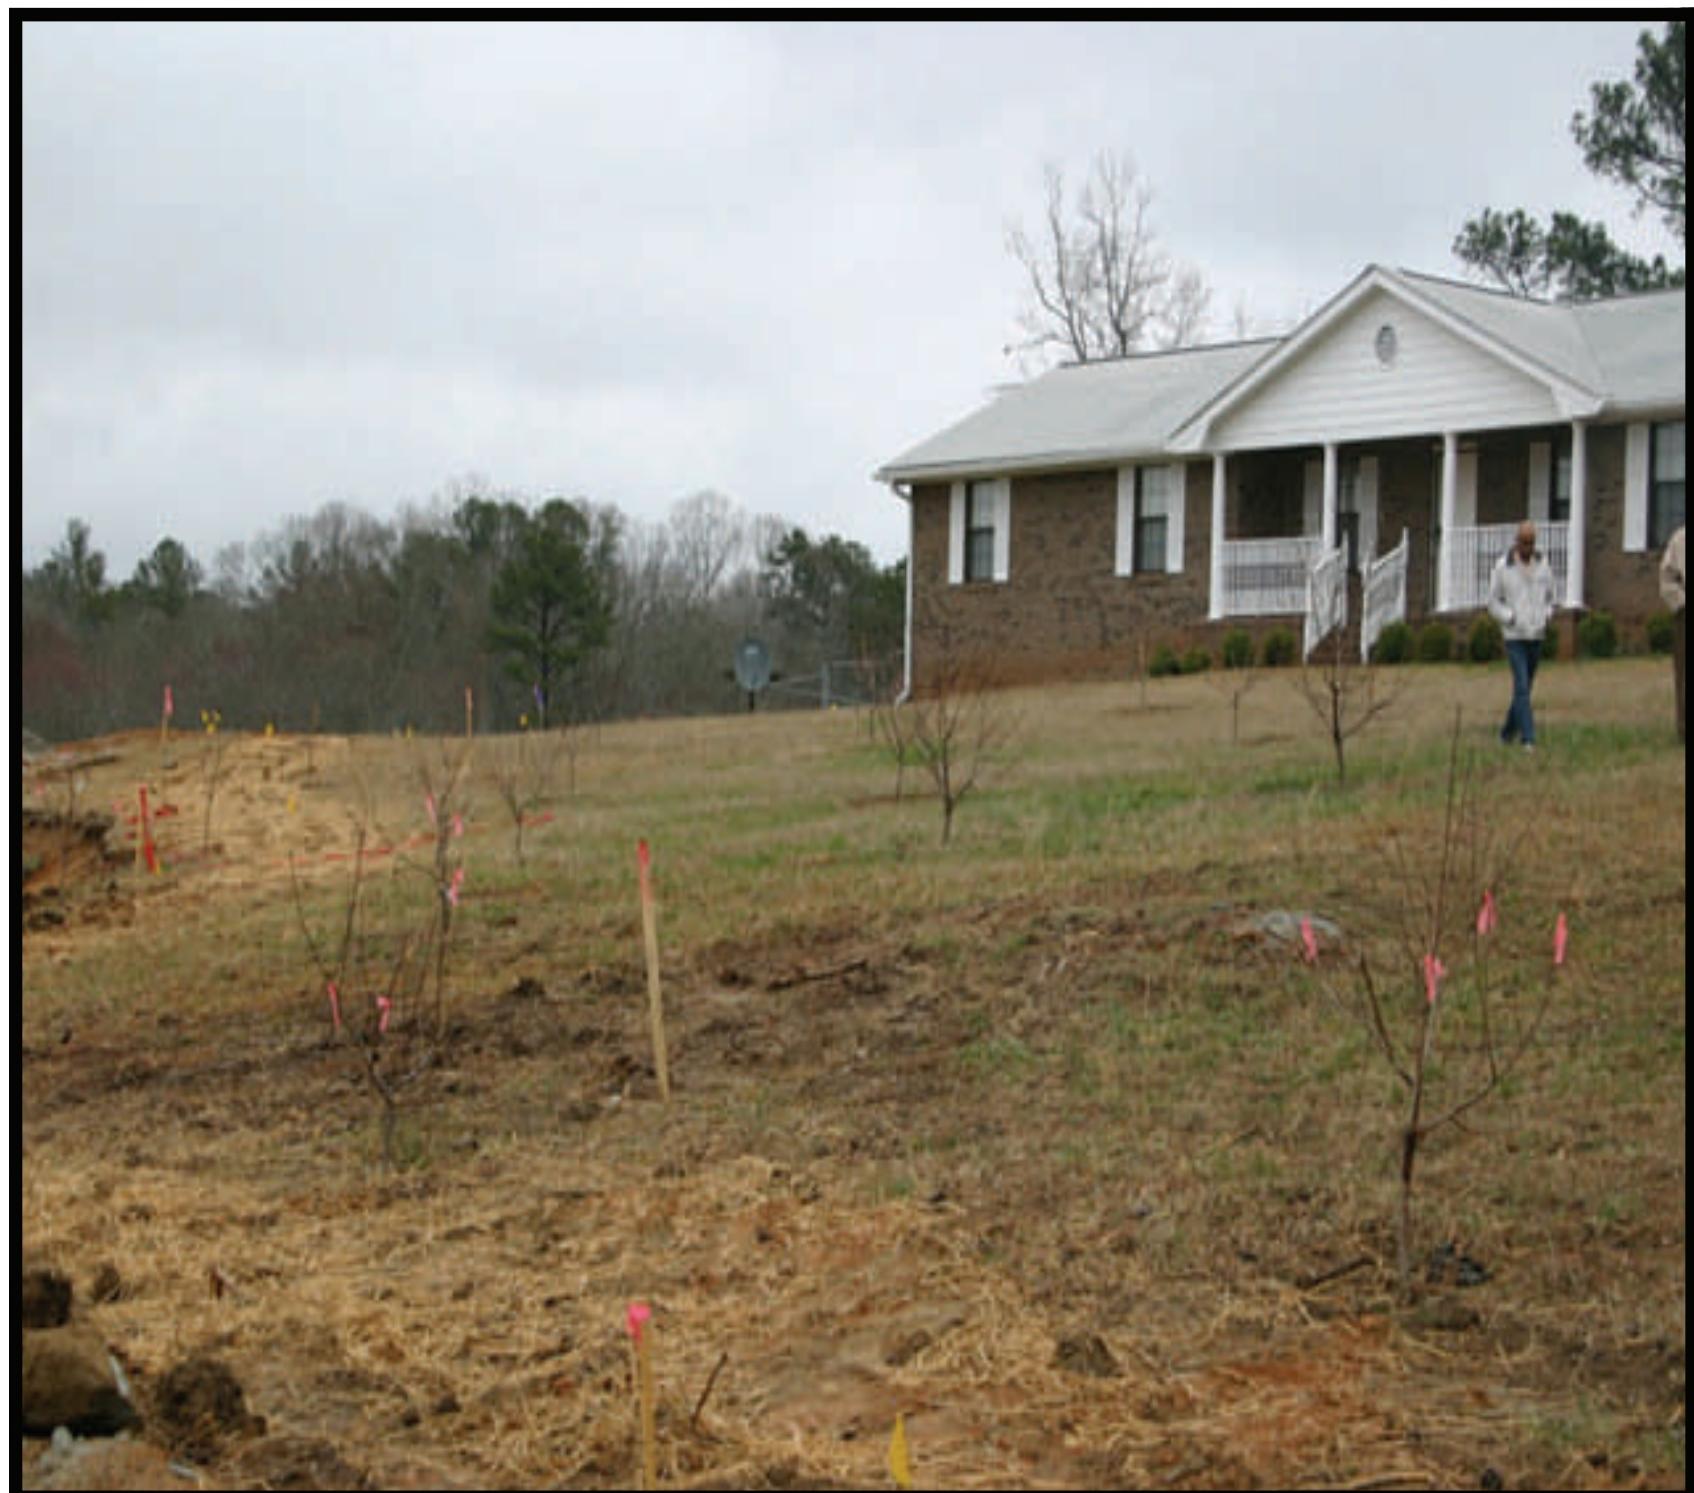
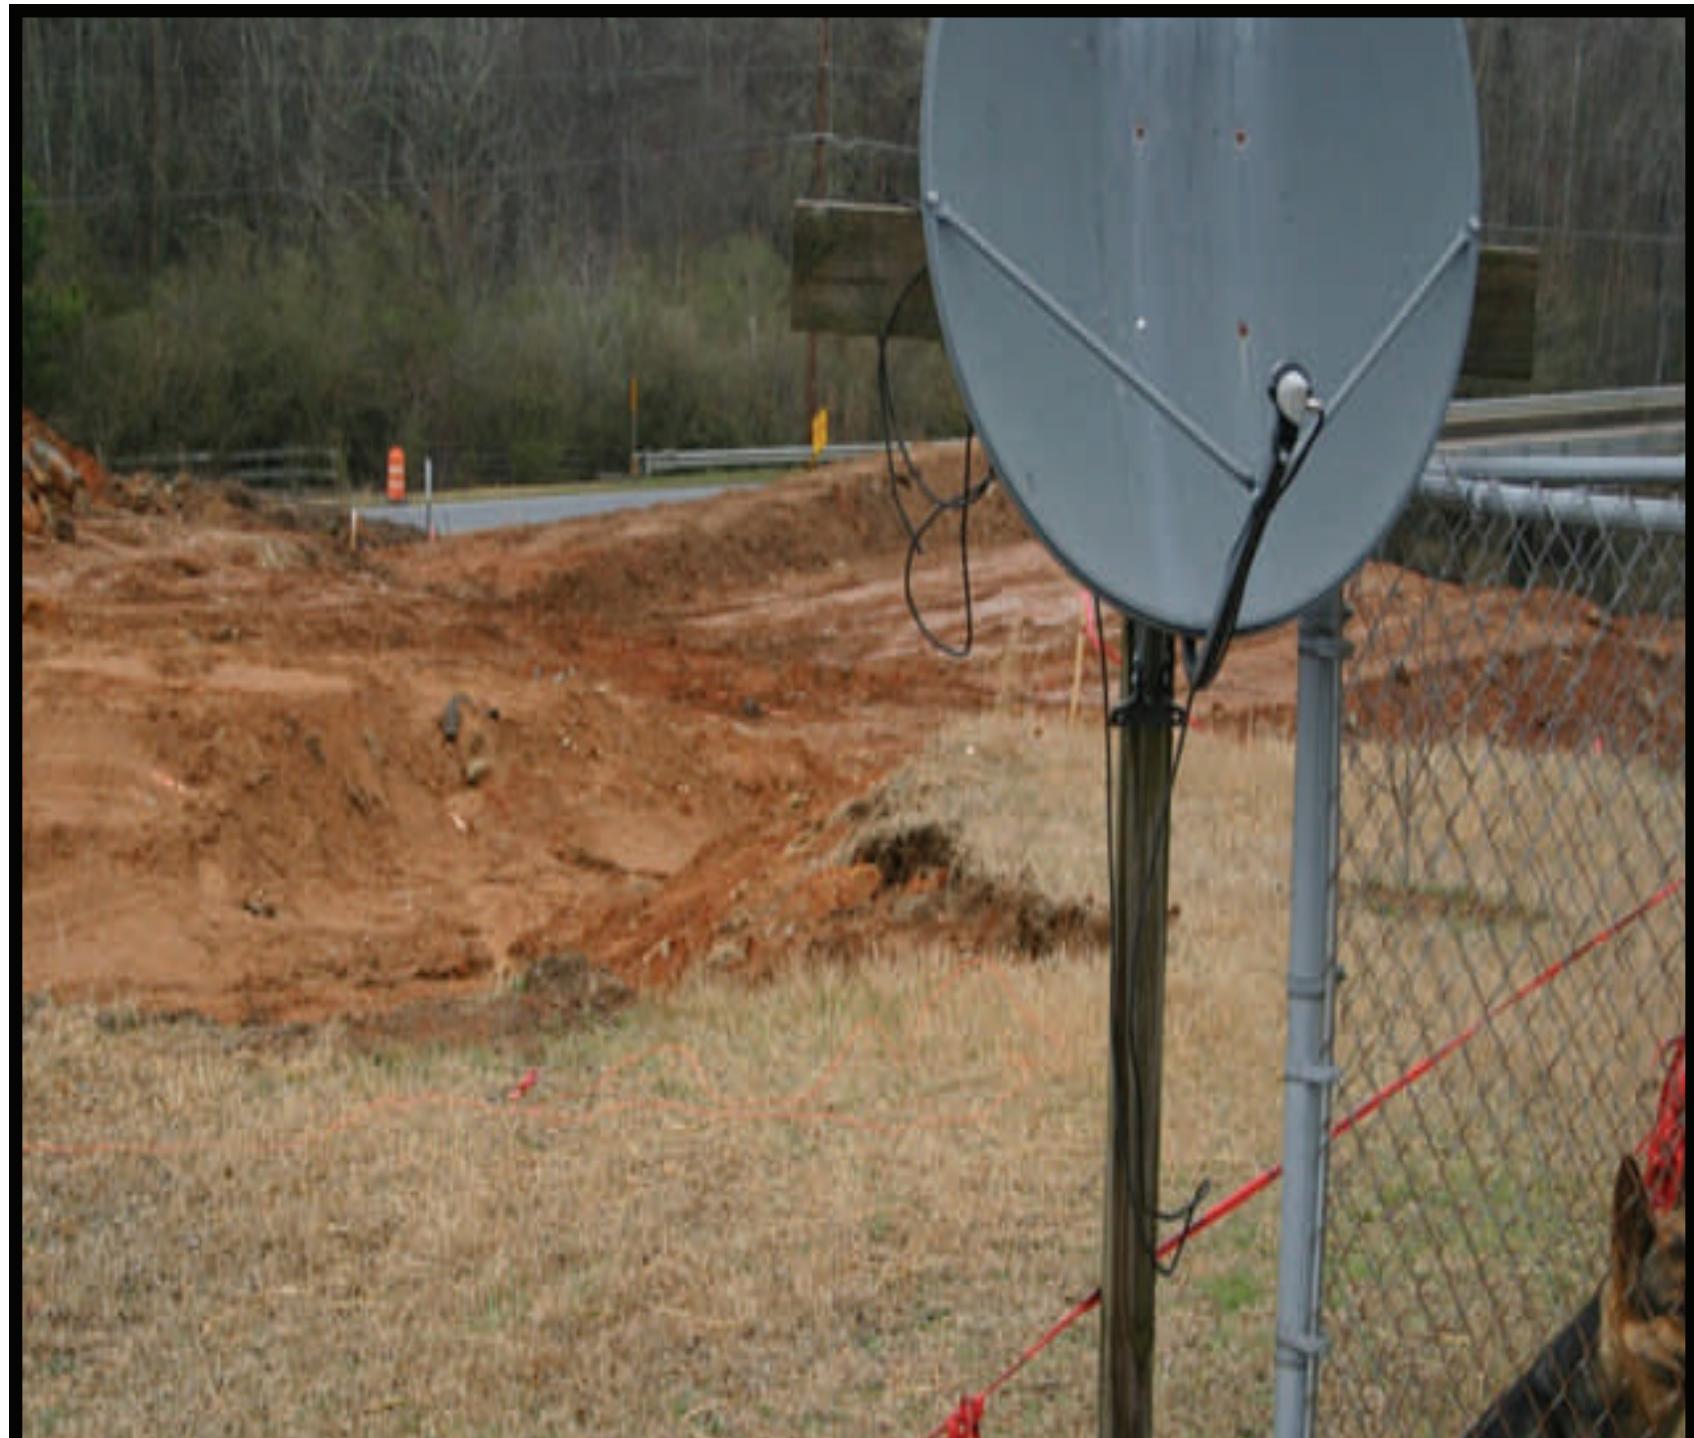
# 439 WESTBRIDGE ROAD

•The front yard is being cut in half by construction of a new bridge on Westbridge Road. Steep slopes will drop from the property line to a concrete drainage system. The cut grade will be around 15-feet off of this side fence.

**We have assured the property owner that the County Engineer will inspect regularly to insure the drainage system is properly installed and functions as designed.**
